A longitudinal study of backcountry track and campsite conditions on the Overland Track, Tasmania, Australia

Grant Dixon¹

Parks and Wildlife Service, Department of Primary Industries, Parks, Water and Environment, GPO Box 1751, Hobart, Tasmania, 7001, Australia

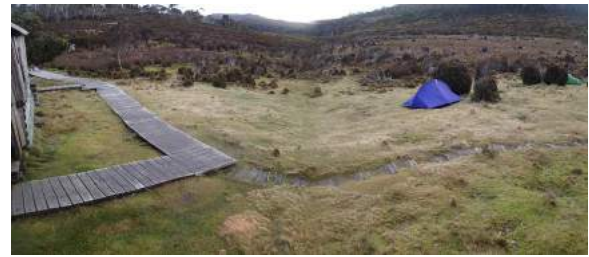
Photo 1. Naturally trampling-resistant grassy campsite (condition class 1; see Table 4) adjacent to old Waterfall Valley hut, Overland Track, Tasmania.

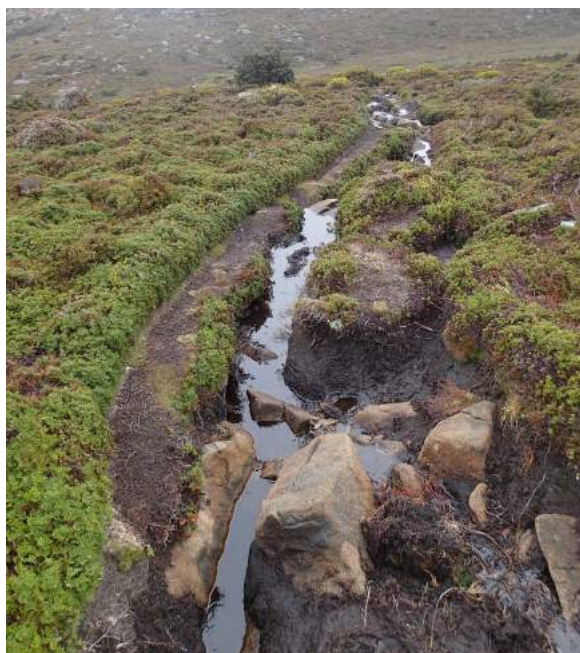
Photo 2. Eroded and braided alpine section of the Mt Oakleigh side track.

tracks remain to be addressed (Photo 2). The inevitable deterioration of much of the 1980s era cordwood is now the cause of some sections of the Overland Track again being in poor condition some 25–30 years later (Photo 4).

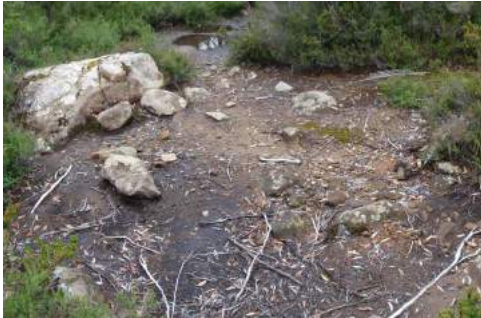
Photo 3. Campsite on the Overland Track impacted by visitor use, with extensive exposed bare soil and signs of erosion. This site would have a condition class of 5 (Table 4).

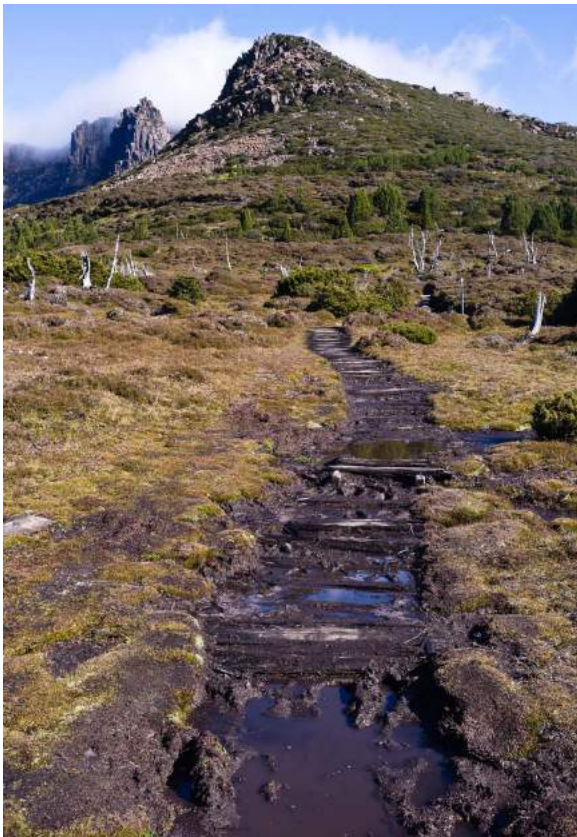
Photo 4. Widening trampled corridor as walkers avoid derelict cordwood. Hardwood logs were laid to provide a hard surface in many muddy peat areas along the Overland Track during the 1980s. Many have now rotted and become a derelict, uneven tread surface that requires replacement.

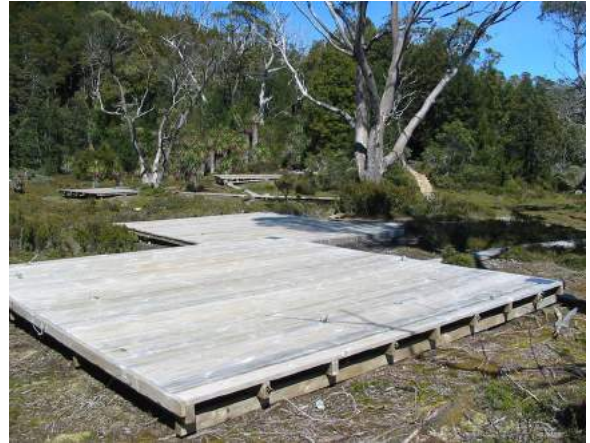
Photo 5. Timber camping platform at Windermere, typical of those installed at most major overnight nodes on the Overland Track since 2001.

Since 1999, Overland Track campsite surveys have been comprehensive, inventorying virtually all sites. During 1999–2005, 21% of the campsites monitored displayed some deterioration, 53% were considered stable and 26% had improved. ‘Improved’ sites included those where campsite hardening (timber tent platform construction) had been undertaken.

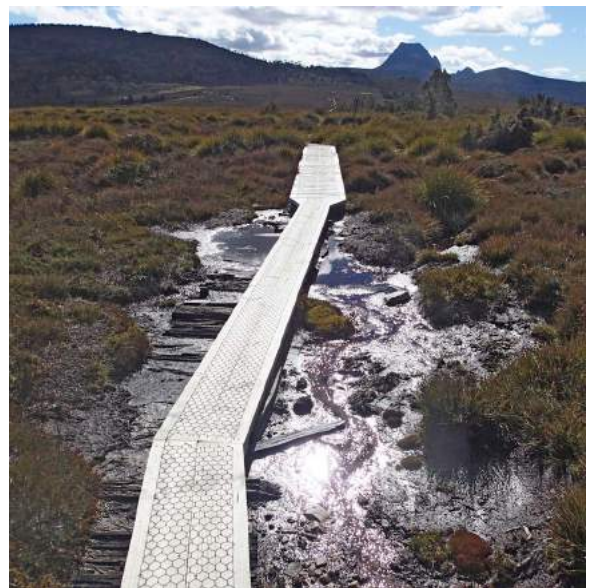
Photo 6. “Planking” is a modern track hardening technique that is relatively efficient and cheap to lay. By 2015 planking had been used to harden 13.3 km of the Overland Track.

avoiding the need to constantly increase the capacity of the infrastructure on the Overland Track (PWS, 2008b). The booking system limits the number of daily departures to 60 walkers (and so the maximum number on the track at any one time), requires all walkers to travel in a north-to-south direction, and limits group sizes to a maximum of 8 (for non-commercial walkers). Since 2005, booking fees have provided reliable funds for an ongoing repair and upgrade program (Photo 6).

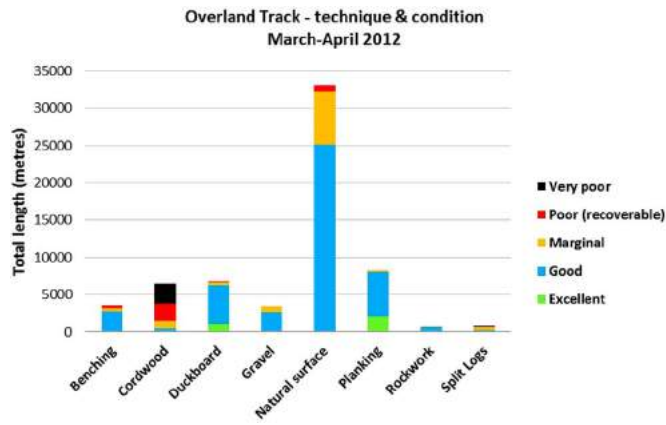
Fig. 4. Total lengths and condition of tread hardening techniques on the Overland Track; example from 2012. Duckboard = boardwalk; rockwork = paving or pitching; natural surface = generally unimproved surface but may have scattered steps or water-bars; planking = photo 6; split logs = locally-sourced fallen logs longitudinally-split and laid like planking. See Table 3 for condition category definitions.

Data can also be presented as a simple chart illustrating a snapshot in time, useful for managers to gain an overall impression of trail conditions. Such charts illustrate the extent and condition of tread surfacing techniques on the Overland Track (Fig. 4), and highlight which side tracks might be the highest priority for future works (Fig. 5), clearly illustrating the extent of the problem of derelict cordwood (Photo 4). Fig. 4 also clearly illustrates the range and extent of tread hardening techniques used on the Overland Track (including 13.3 km of planking, 7.2 km of duckboard and 2.6 km of cordwood) but the majority of the track (38 km, or 60%) still comprises a natural surface (this includes sections of old benching, the tread of which remains essentially natural), much of which remains in acceptable condition.

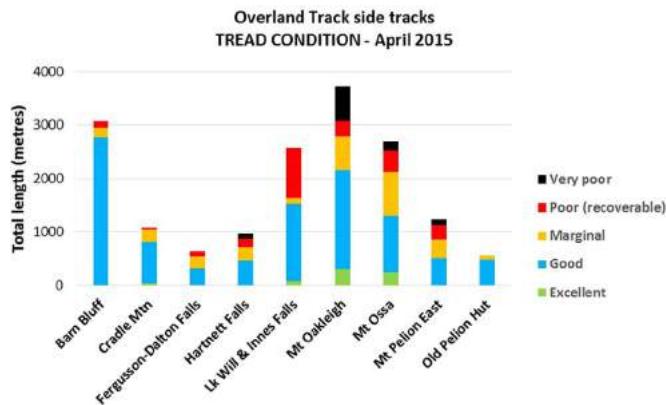
Fig. 5. Total lengths of various tread condition classes on the Overland Track side tracks; 2015. See Table 3 for condition category definitions.

Nine major destination side tracks, with a total length of 16.6 km, are associated with the Overland Track. About 20% of the total length these tracks were in *poor* or *very poor* condition in 2015 (Fig. 5), a slightly higher proportion than in 2012, despite some works in the interim. The major extent of problems lay on the Mt Pelion East and Mt Oakleigh tracks.

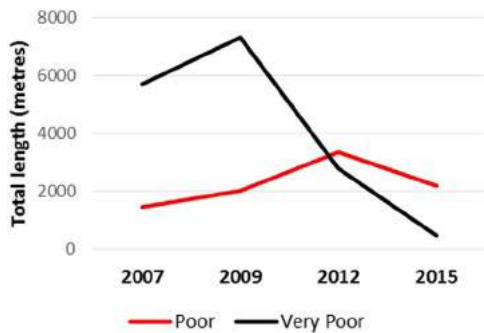
Fig. 6. Change in total length of the Overland Track in “poor” or “very poor” condition (see Table 3), 2007–2015.

As illustrated in Fig. 6, in an overall sense, while works during 2007–09 did not fully balance ongoing deterioration elsewhere, a dramatic improvement has been observed since 2009. By April 2015, only 2.7 km of the Overland Track (and about 4% of its total length) remained in *poor* or *very poor* condition (see Table 3), compared to 7.2 km in March 2007 and 9.3 km in 2009. About half of the problem areas that remained to be addressed (in April 2015) were deteriorating unimproved track sections that still require hardening with the remainder mostly comprising decrepit old surfacing (mostly cordwood).

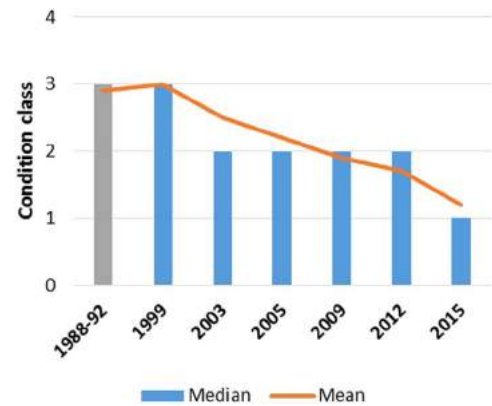
Fig. 8. Median and mean condition class (see Table 4) for campsites on the Overland Track, 1999–2015. Sites hardened by the construction of timber platforms (Photo 5) post-2000 have been considered class 2 for this exercise. Data includes all campsites since 1999 but only a sub-set of 42 campsites for 1988-92, but the latter is included here for comparison purposes.

An improving trend in Overland Track campsite condition is evident from several indicators; amongst many overnight node campsite clusters (e.g. Fig. 7), but is particularly clear when considering the change in median or mean condition class of all Overland Track campsites over the last 10–15 years, and comparison with a sub-set of these sites some 25 years ago (Fig. 8).

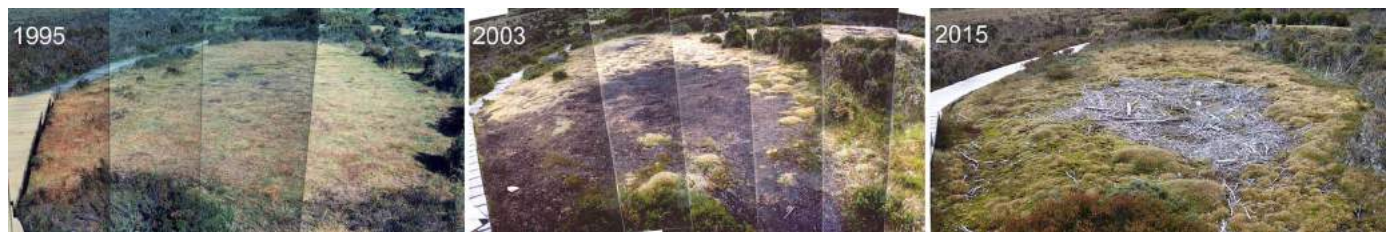
Photo 7. Evolution of a campsite near Waterfall Valley hut; 1995 (left, condition class 1), 2003 (centre, class 3–4) and 2015 (right, recovery to class 2). This campsite was closed in 2005.
