A longitudinal multi-method study of recreational impacts in the Arthur Range, Tasmania, Australia

Grant Dixon*, Martin Hawes¹

Parks and Wildlife Service, Department of Primary Industries, Parks, Water and Environment, GPO Box 1751, Hobart, Tasmania 7001, Australia

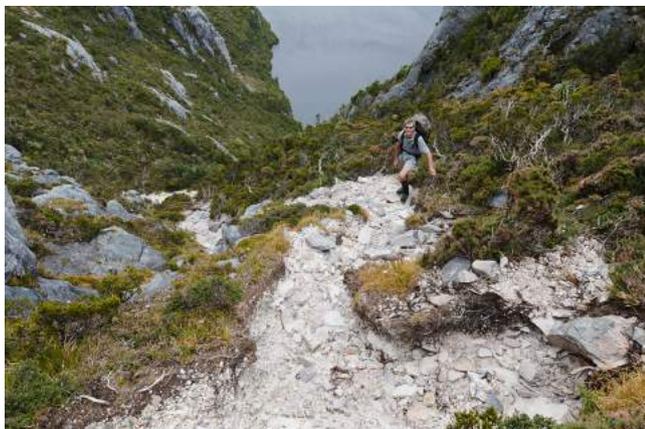
Photo 2. Severe track erosion was evident in parts of the Arthur Range by the late 1980s and has increased substantially since.

significant impacts have developed owing to the low resistance and resilience of the environment to trampling (see Section 2). A well-worn, trampled route existed through much of the Eastern and Western Arthur Ranges by 1980. This route was visitor-created and mostly poorly sited in terms of long-term stability. By the late 1980s, substantial damage was already occurring on some track sections and campsites (Photo 2).

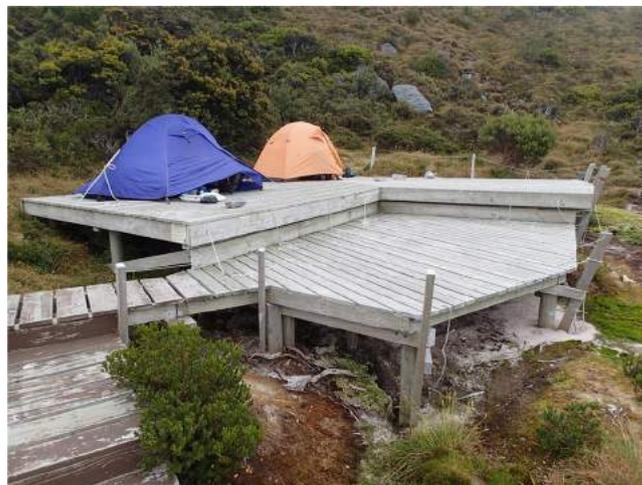
Photo 3. Camping platforms and associated infrastructure were constructed at a number of seriously-impacted sites between 1994 and 2002.

In the Western Arthur Range, the late 1990s saw hardening of many popular campsites (12 sites at four camping nodes were hardened; Photo 3) but also measurable deterioration of some unimproved campsites, most within the western and central regions of the range. Post-2000 campsite deterioration has also occurred, mostly on unimproved sites within the low use eastern region of the range: eight of the 66 recorded campsites have deteriorated (increased condition class by at least 1 or notably expanded) since 2000. At least five new campsites have also appeared, some in the low-use eastern region of the range (the uncertainty due to the possibility some sites may have been missed during earlier surveys).

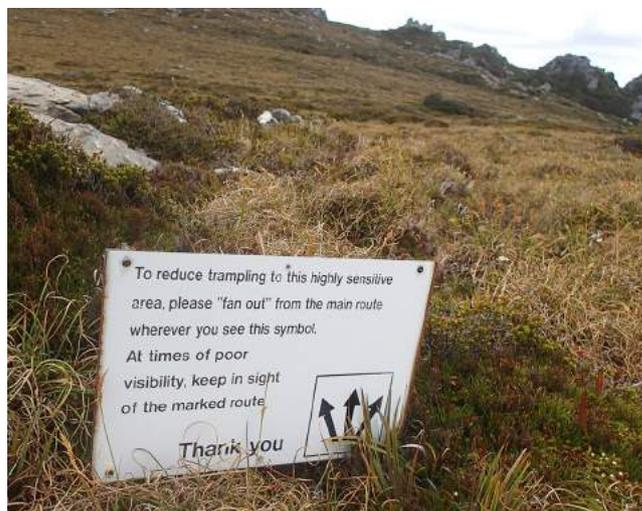
Photo 4. Sign advising walkers to "fan-out" to minimise trampling impacts when traversing a still-trackless section of alpine moorland in the Eastern Arthur Range.

Since the 1990s a fan-out (dispersal) strategy has been promoted at a number of alpine moorland localities in the Arthur Range, with the goal to disperse walker trampling and minimise the risk that permanent tracks would develop (Photo 4). In many instances, the primary intent of this approach has been to forestall track development and major vegetation loss until more intensive hardening could be carried out.

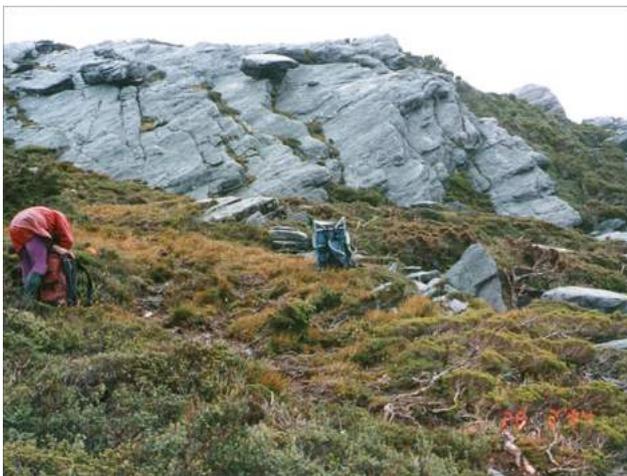
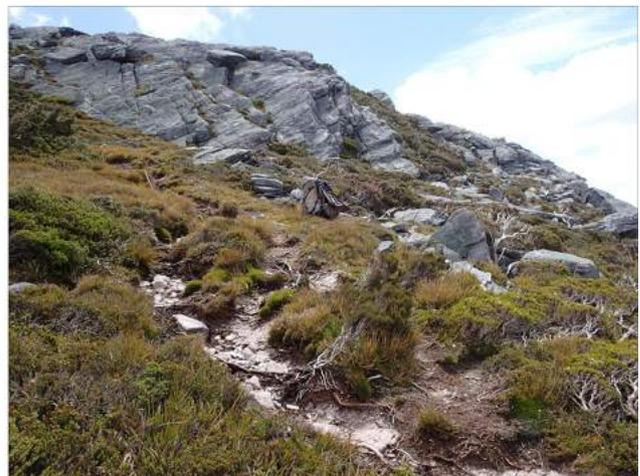
Photo 5. Track erosion and widening on southern slope of The Phoenix, in the low-use eastern region of the Western Arthur Range; 1994 (left), 2014 (right).

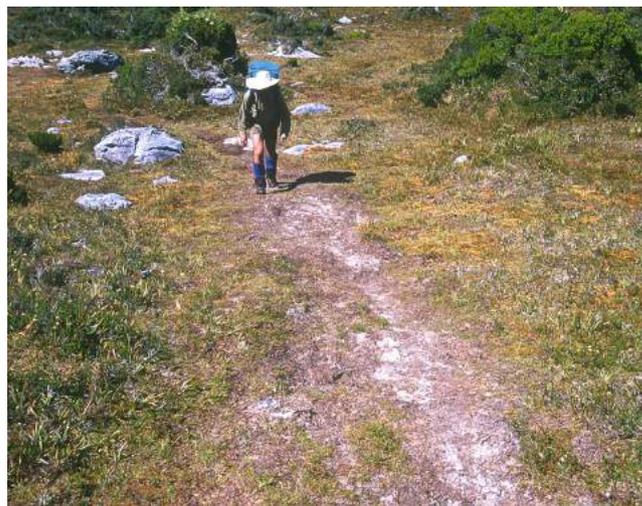
Photo 6. Incipient track on alpine moorland, Eastern Arthur Range.

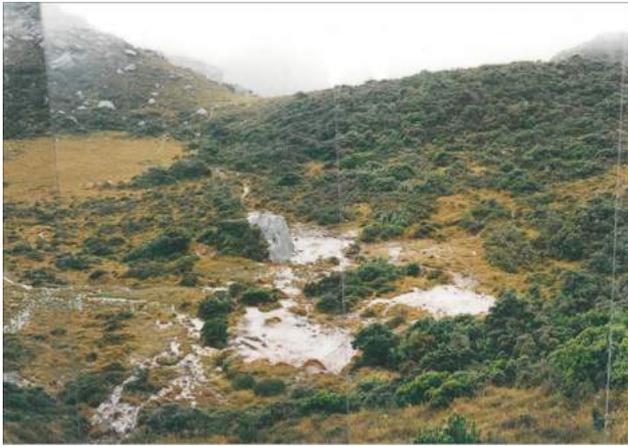
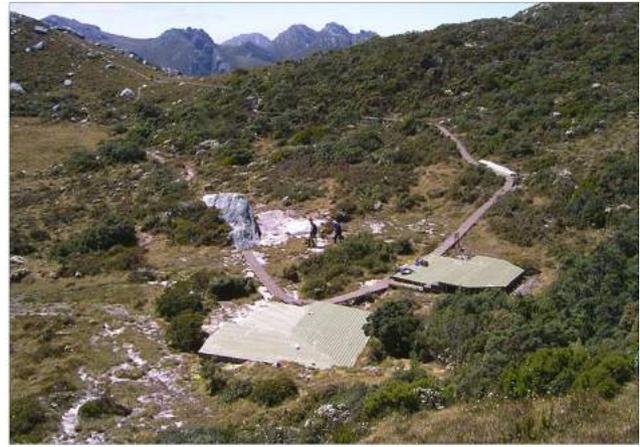
Photo 7. High Moor campsite, in Western Arthur Range, before (1995) and after (2002) installation of camping platforms.

of very seriously impacted campsites (because tent platforms were constructed over them in many cases; see Photo 7). There has been a concomitant reduction in the proportion of moderately-impacted sites (see Fig. 3), probably due to slow recovery of disused sites with the capacity to recover and perhaps also due to reduced usage (see Section 5.1).

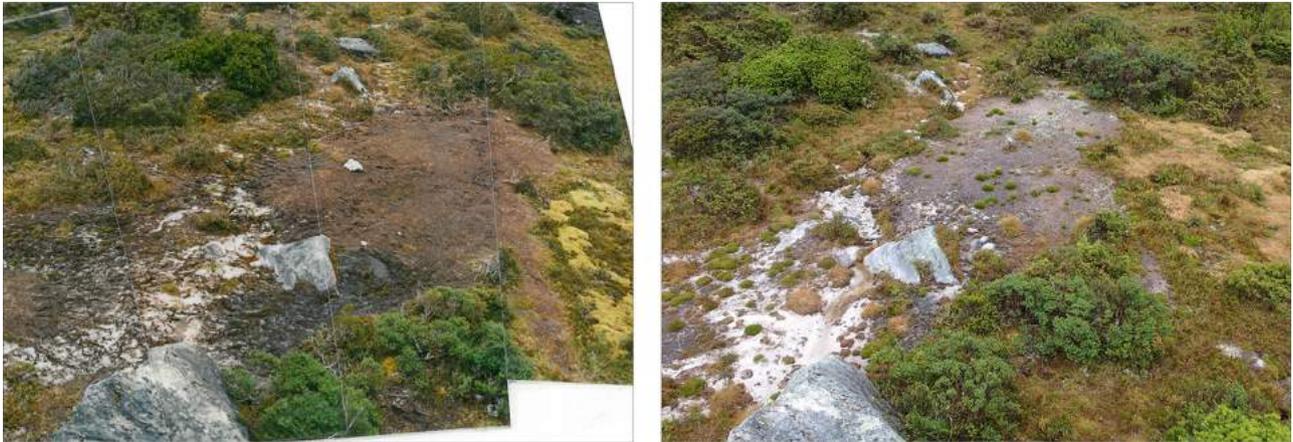
Photo 8. Alpine campsite in Western Arthur Range with minimal revegetation 19 years after site closure; 1995 (left) vs 2014 (right).
